Supply Name	Carlton Village Water Supply
Risk Assessment Date	6 September 2023

Description of the Supply

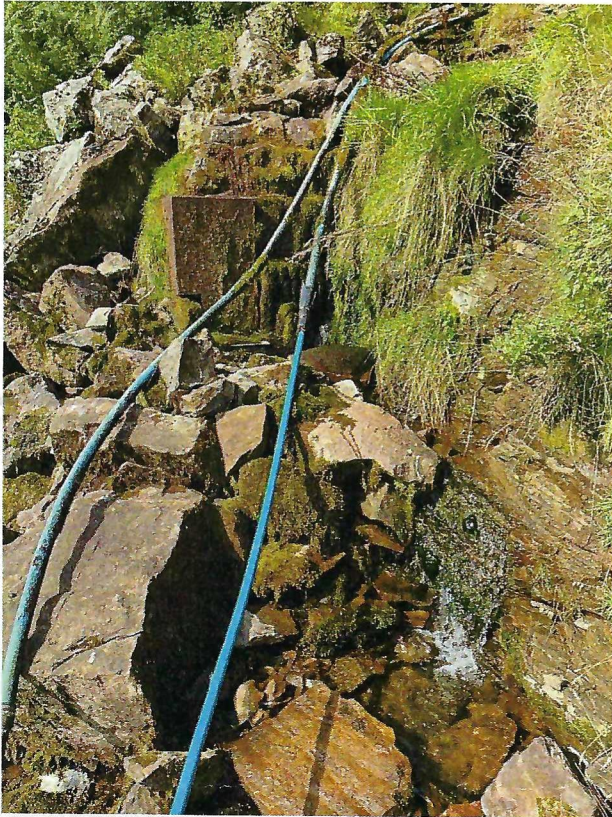
Two blue alkathene pipes, carrying water from the underground pool in the hillside, no longer converge in the covered collection chamber. Instead, they are connected to further lengths of blue pipe laid on the ground to the intermediate tank. This pipe and the joins connecting the lengths are vulnerable to damage and weathering.

The original underground pipe to the intermediate tank was damaged by a rockfall/landslip in recent years.

The pipe on the left of this picture shows signs of scoring or cracking near the joint.

The wider bore black plastic pipe coiled nearby is intended to replace the two lengths of blue pipe.

- The pipe (or pipes) from the Melbecks source to the intermediate tank should be dug in underground wherever possible to prevent damage and potential loss of supply. This should be done as soon as possible and before the end of the year when the potential for severe frosts increases. The hanging joints in the line of the waterfall are particularly vulnerable as the hose clips rust and decay and a more permanent solution should be found.

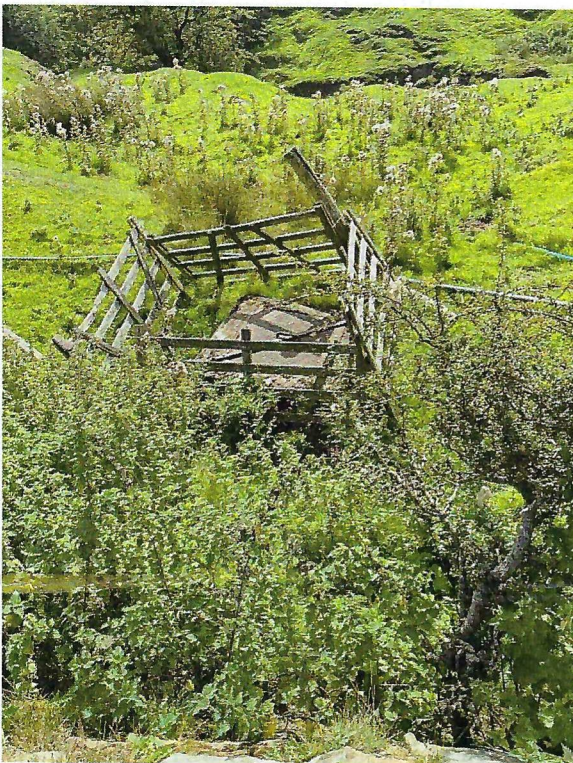
The stone built intermediate tank has a locked metal inspection cover and is surrounded by a fence. However, the fence is neither stock proof nor rabbit proof.

At the time of assessment, there was a good volume of water passing through this tank and it wasn't possible to see the coarse filter.

- Fences need to be in sound condition, stock and rabbit proof
- Keep a regular check on the borehole chamber for water/soil ingress and ensure the outlet pipe is kept clear
- The long dry periods over the last couple of years and changing weather patterns are causing managers and users of private water supplies to look at the long-term sustainability of their supplies and put in measures to ensure a sufficient supply of potable water.

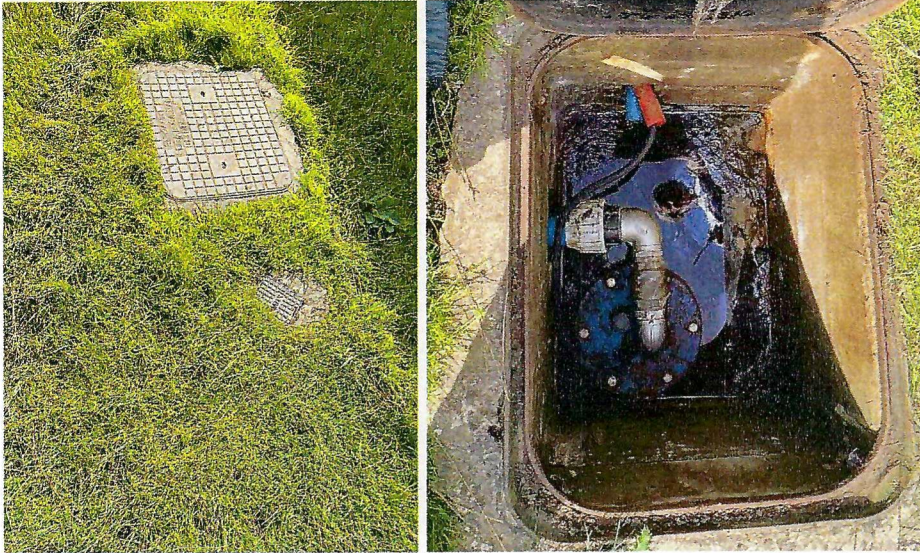
The borehole was drilled in 2011 and is positioned adjacent to the treatment shed in an area where vehicular access is required. Thus, the chamber is below ground. It is a concrete structure with a metal inspection cover and the headworks are sealed.

Soil/stones in the collar for the inspection cover prevented it from being seated fully. Water and sludge were present in the base of the chamber and around the outlet pipe.

The chamber should be regularly checked and cleared, particularly around the outlet pipe, to prevent water building up in the chamber to the point where it could compromise the borehole.

This was done the following day.

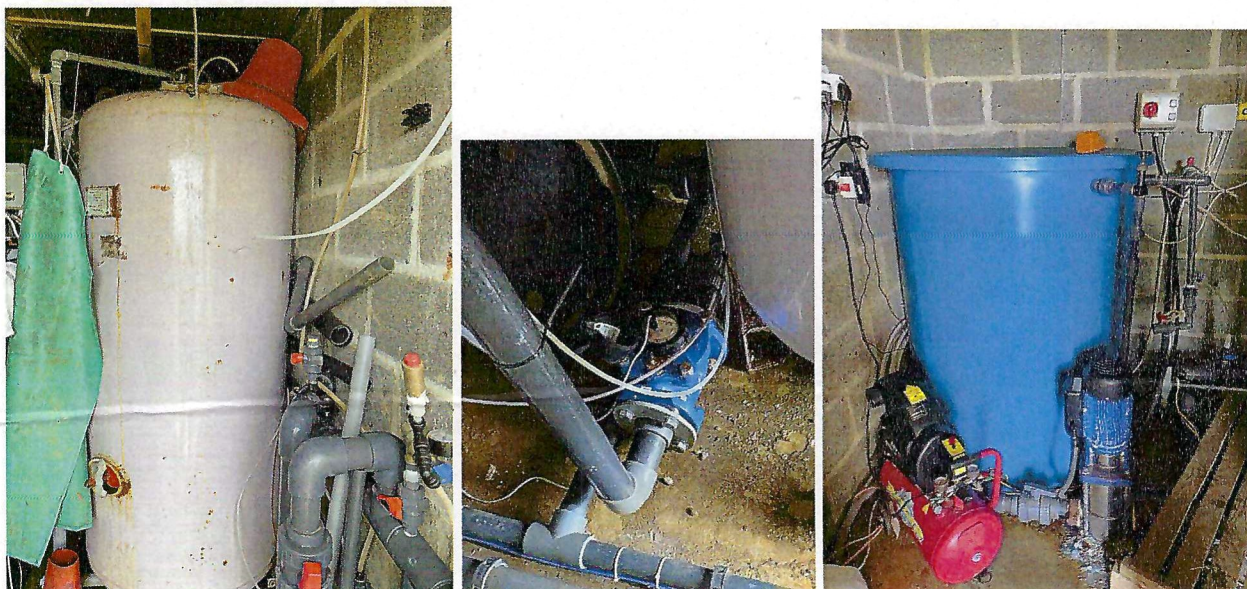
Inside the treatment shed the equipment is the same as in the original assessment with the addition of the pressure vessel and pump for the borehole and changes to the pipework to allow

switching between sources etc. The main dosing system was not in use at the time of inspection. The back up was in use. 2 of the filters are automatically backwashed while the 3rd is manually backwashed.

Attempts have been made to source replacement of the aging treatment system, but no decisions have been made to date.
